**SPECIAL ENVIRONMENTAL INSPECTION REPORT  
(ELECTRONICALLY SUBMITTED)  
FEDERAL ENERGY REGULATORY COMMISSION  
Division of Hydropower Administration and Compliance**

**Project Name** Middle Fork American River **Project**  
**No.** 02079

**Development** Ralston Afterbay Dam and Oxbow Powerhouse

**Parts of Project Inspected** Ralston Afterbay and Middle Fork American River downstream

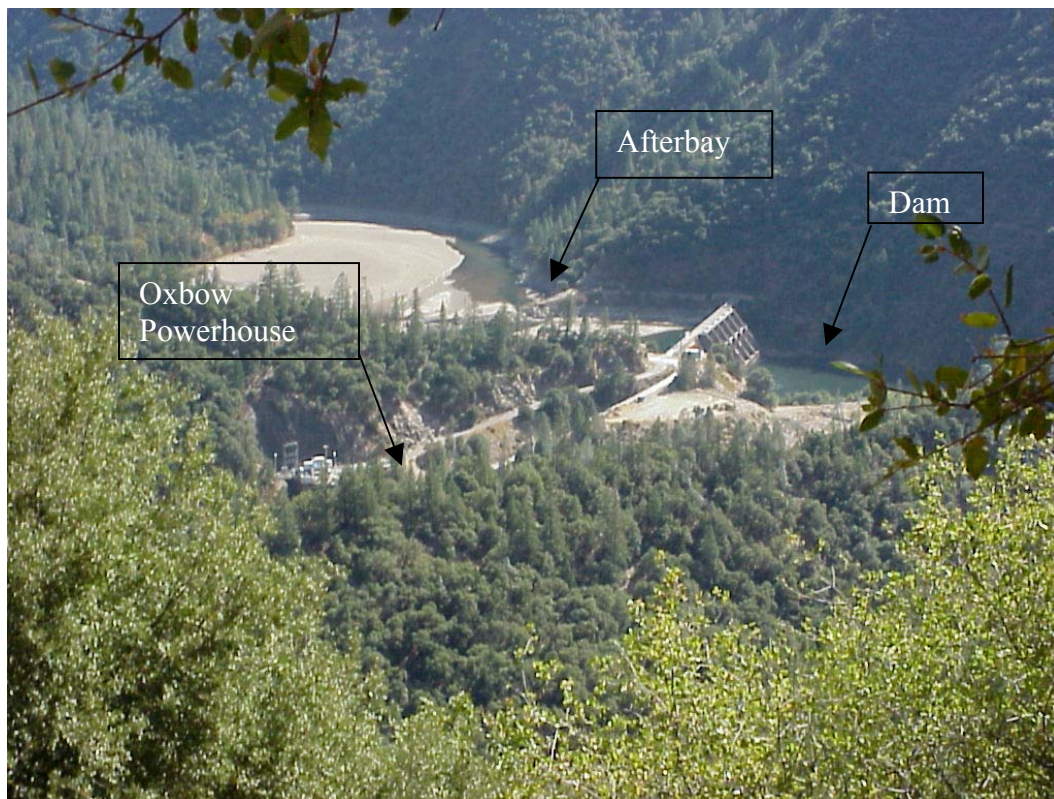
Photo 1. Ralston Afterbay Dam and afterbay at a very low elevation (note sand bars).

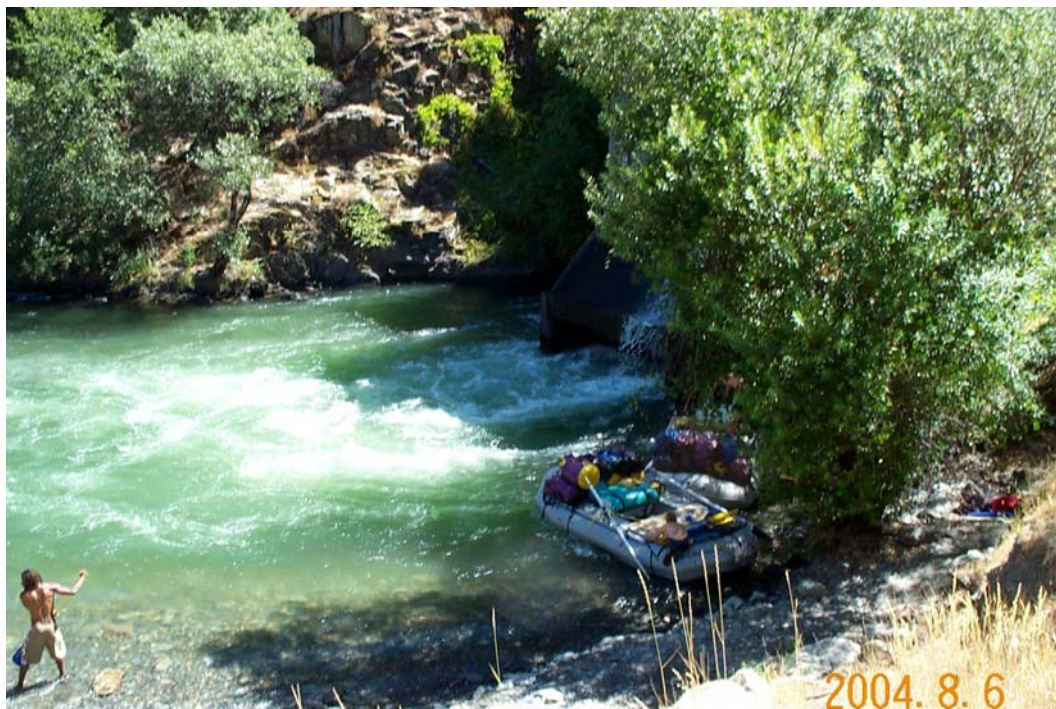
The sudden, unexpected release of water from the Ralston Afterbay did not cause any injuries or deaths, although the amount of water released had the potential to cause them. The river below the dam receives heavy use from commercial rafting companies, which use the Oxbow Powerhouse tailrace channel for launching (Photo 2). The release occurred early enough in the morning that no rafters, gold miners, swimmers, anglers or other recreationists were on the river when it occurred.

Photo 2. Rafters preparing to depart the Oxbow Powerhouse tailrace.

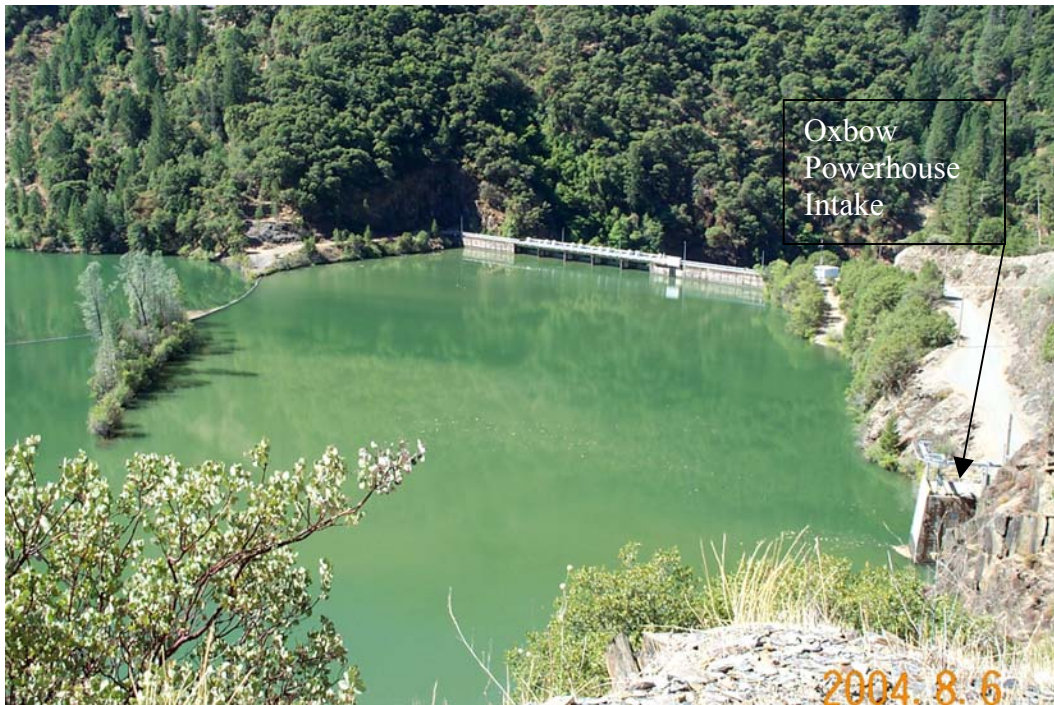
No evidence of channel erosion was observed and no mud was deposited in the river channel downstream of the dam. The licensee reported during the inspection that as much as 10 feet of water remained in the afterbay when the gates were closed. Some turbidity was present in the afterbay, likely a result of its partial draining and refilling, which allowed the inflow to cut through exposed fine sediments. This material was being transported to the river downstream of the dam by flow from the Oxbow Powerhouse, but no streambed sedimentation was observed (Photos 3 and 4).

Photo 3. Turbid water in the Ralston Afterbay.

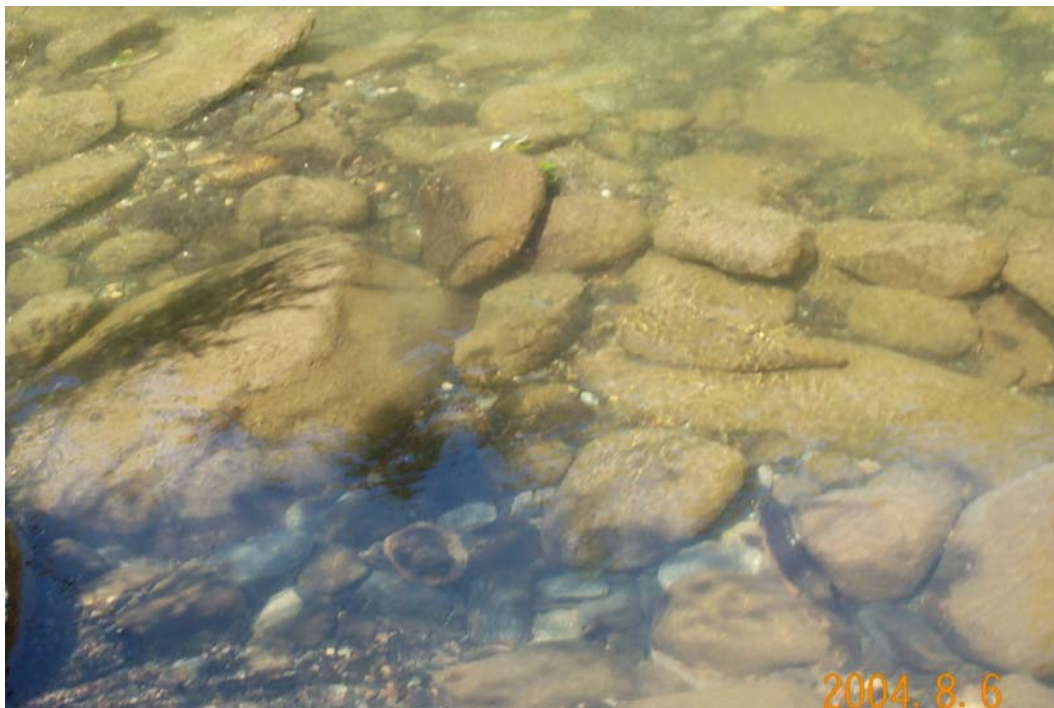
Photo 4. Water clarity in the Middle Fork American River below Ralston Afterbay.

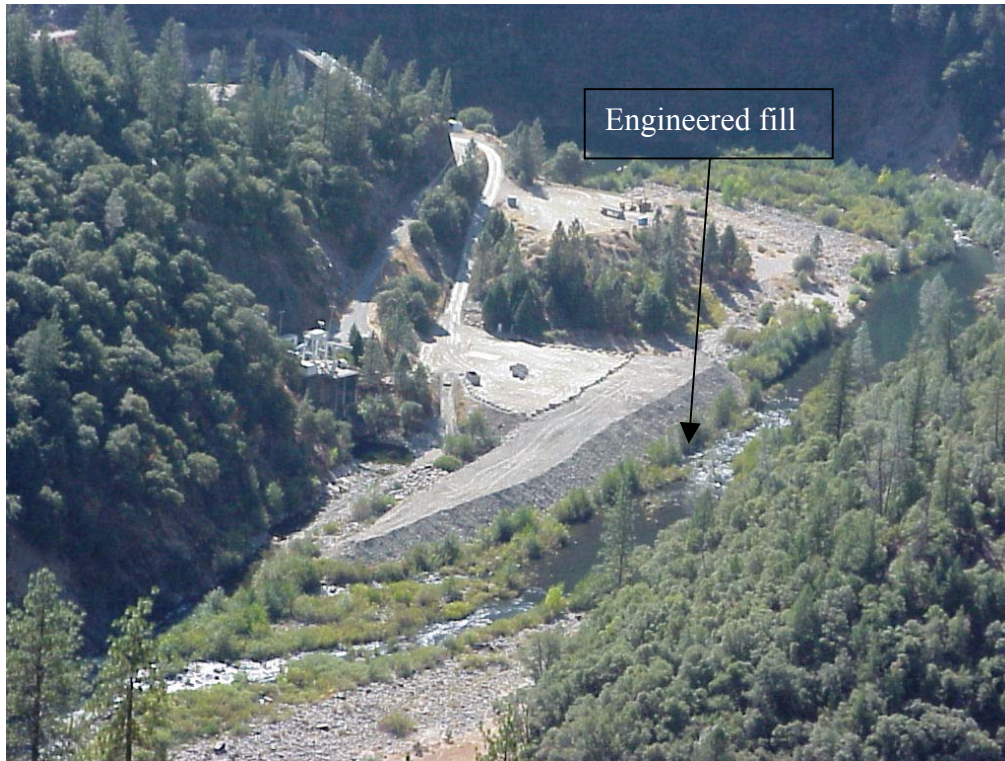
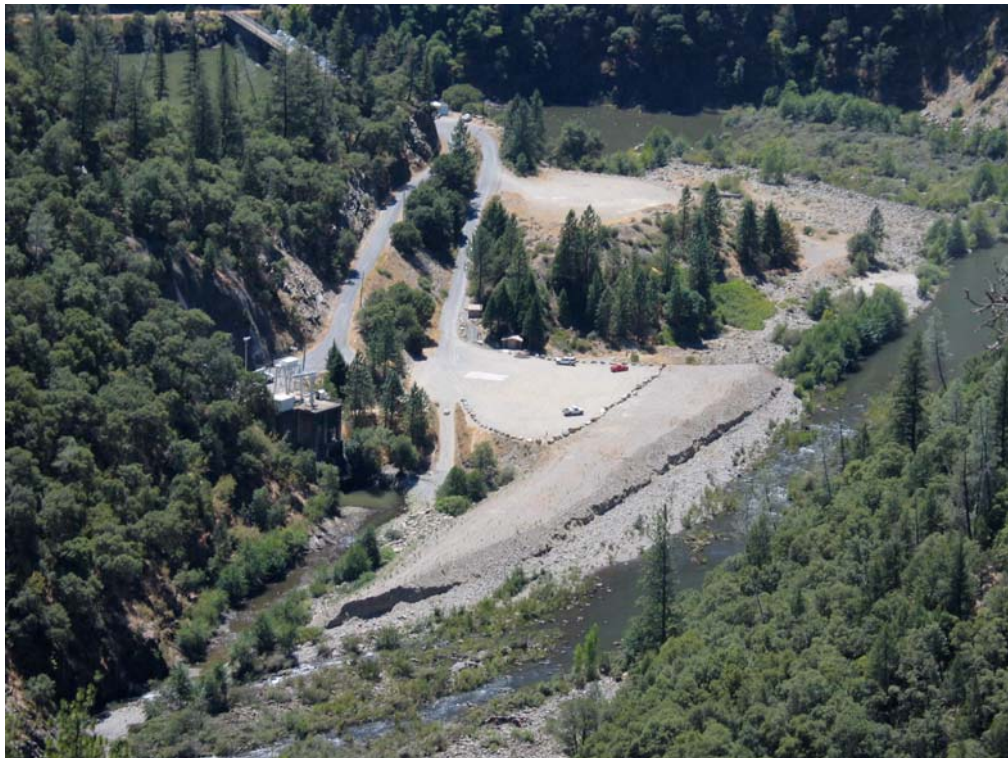
Inspection of the engineered fill designed to provide gravel to the lower river showed a

significant volume of material had been mobilized by the incident (Photos 5 through 8). Flows during the past two run-off periods had not been high enough to move any material. The licensee is preparing an estimate of the amount of gravel transported by the flow.

Photos 5 and 6. Engineered fill near the Oxbow Powerhouse before and after the incident.

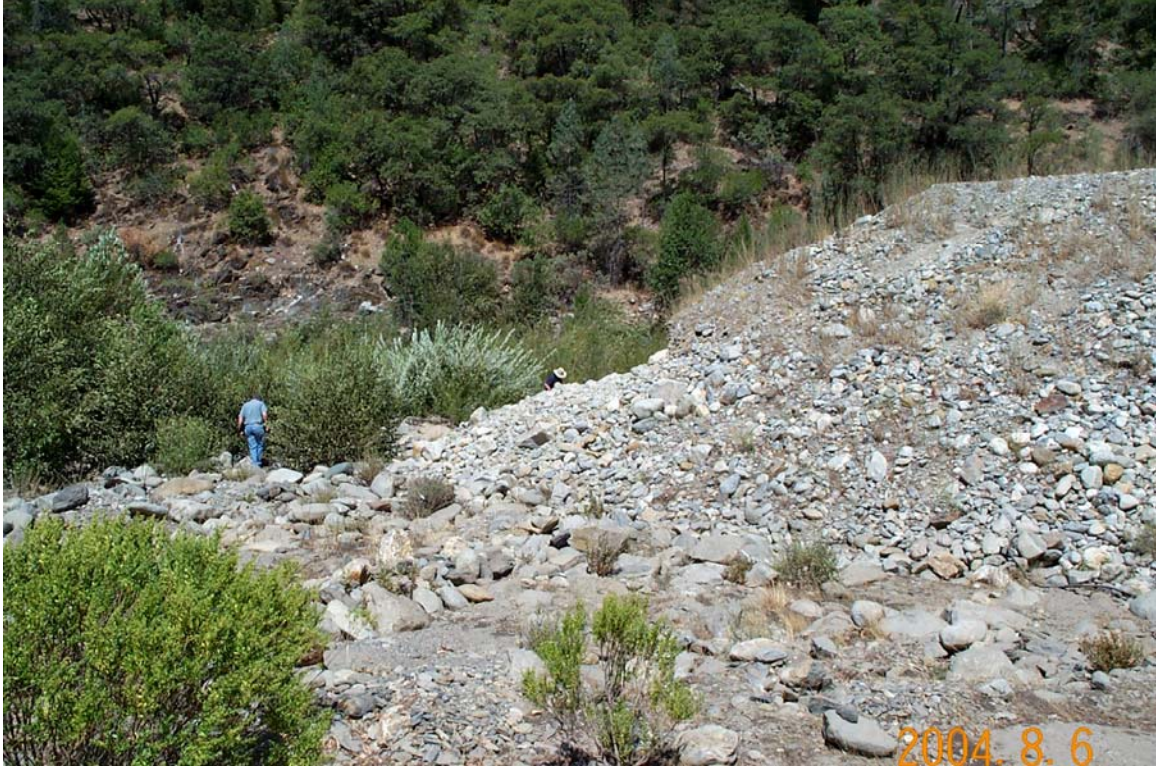
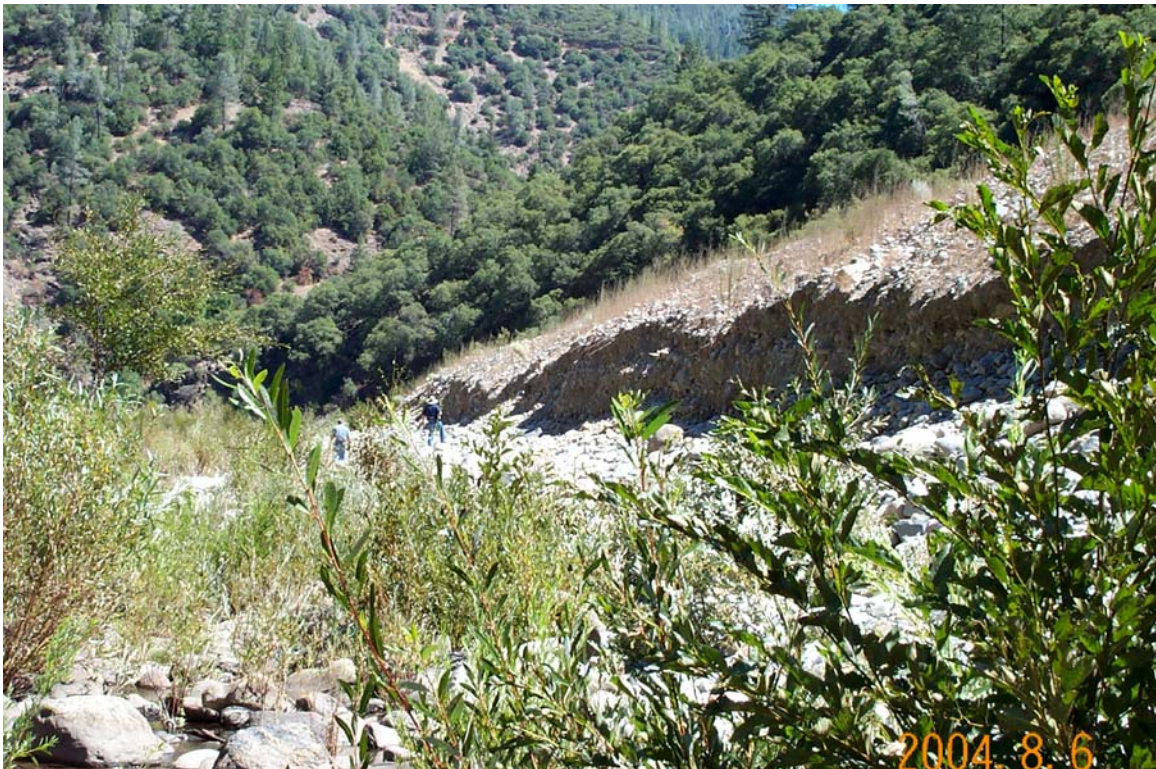
Photos 7 and 8. Edge of the engineered fill after the incident.
