Placer County Water Agency

August 19, 2004

Re: FERC Project No. 2079-CA; NATDAM No. CA00856
Ralston Afterbay Dam, State of California No. 1030-4, Placer County

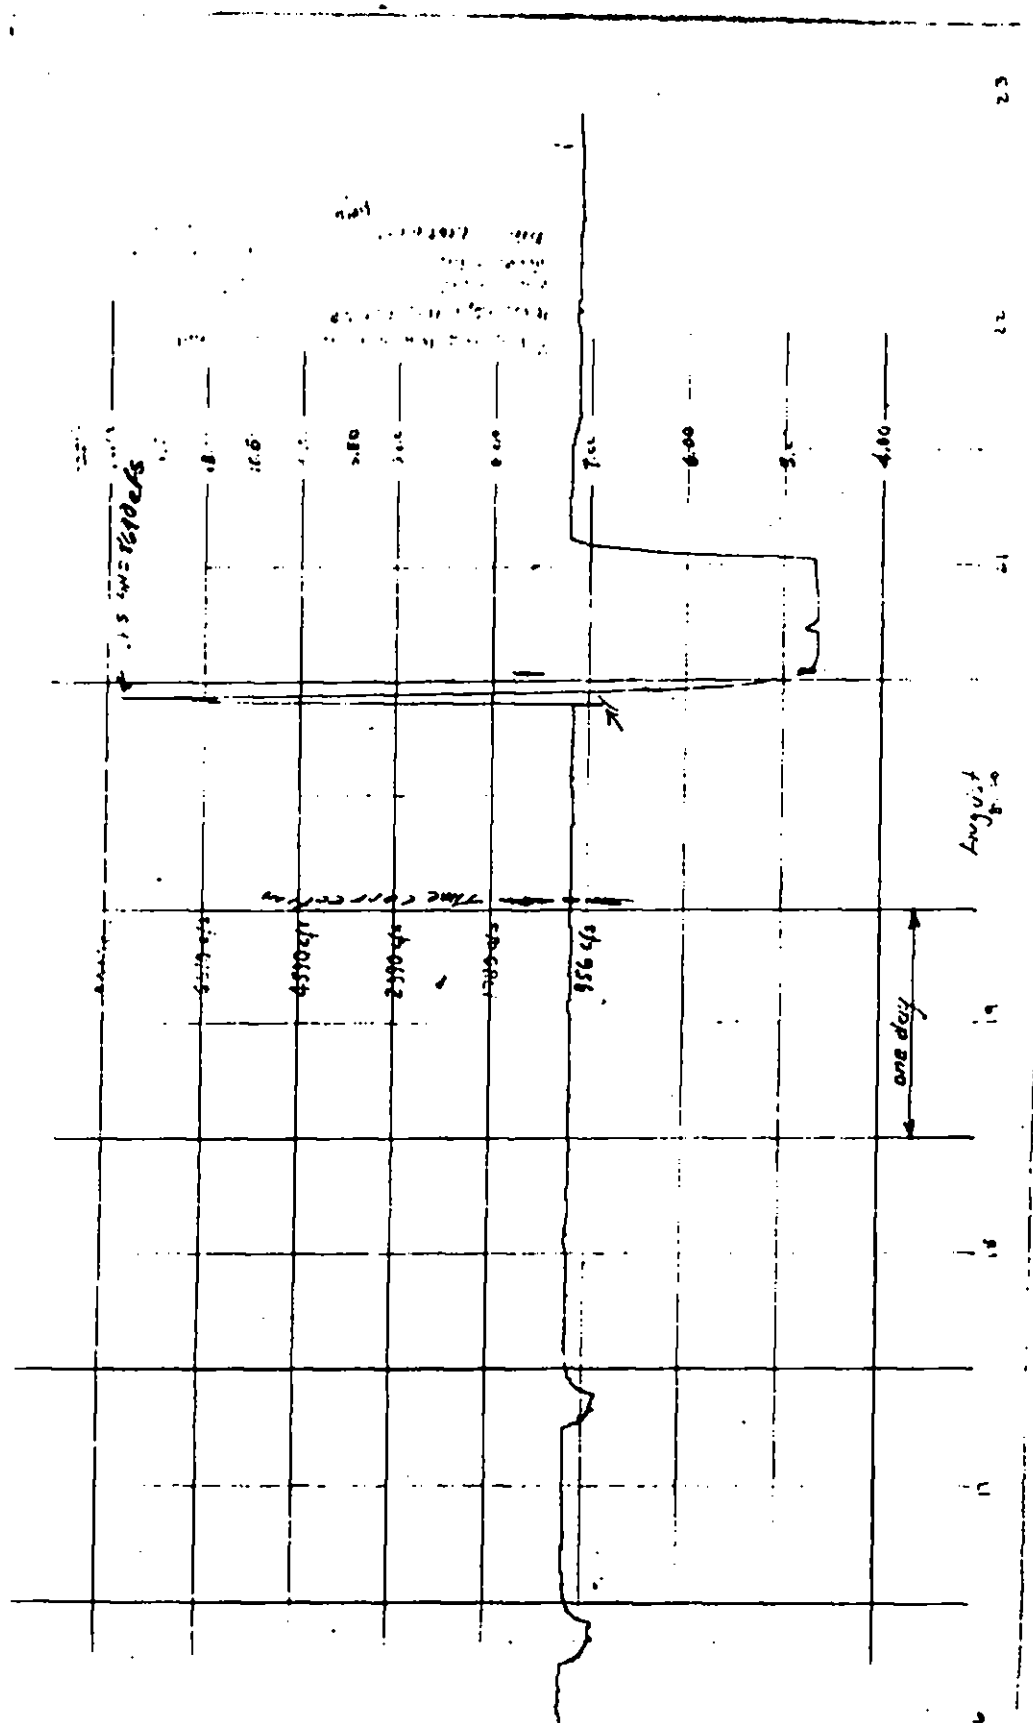
Chart from flow recorder, Middle Fork of the American River near Foresthill - August 17 - 22, 1970 - Chart shows Ralston Afterbay gate opening.
