# New Concepts in Fish Ladder Design: Analysis of Barriers to Upstream Fish Migration, Volume IV of IV

Investigation of the Physical and Biological Conditions Affecting Fish Passage Success at Culverts and Waterfalls

Final Report
1982 - 1984

Patrick D. Powers
and
John F. Orsborn

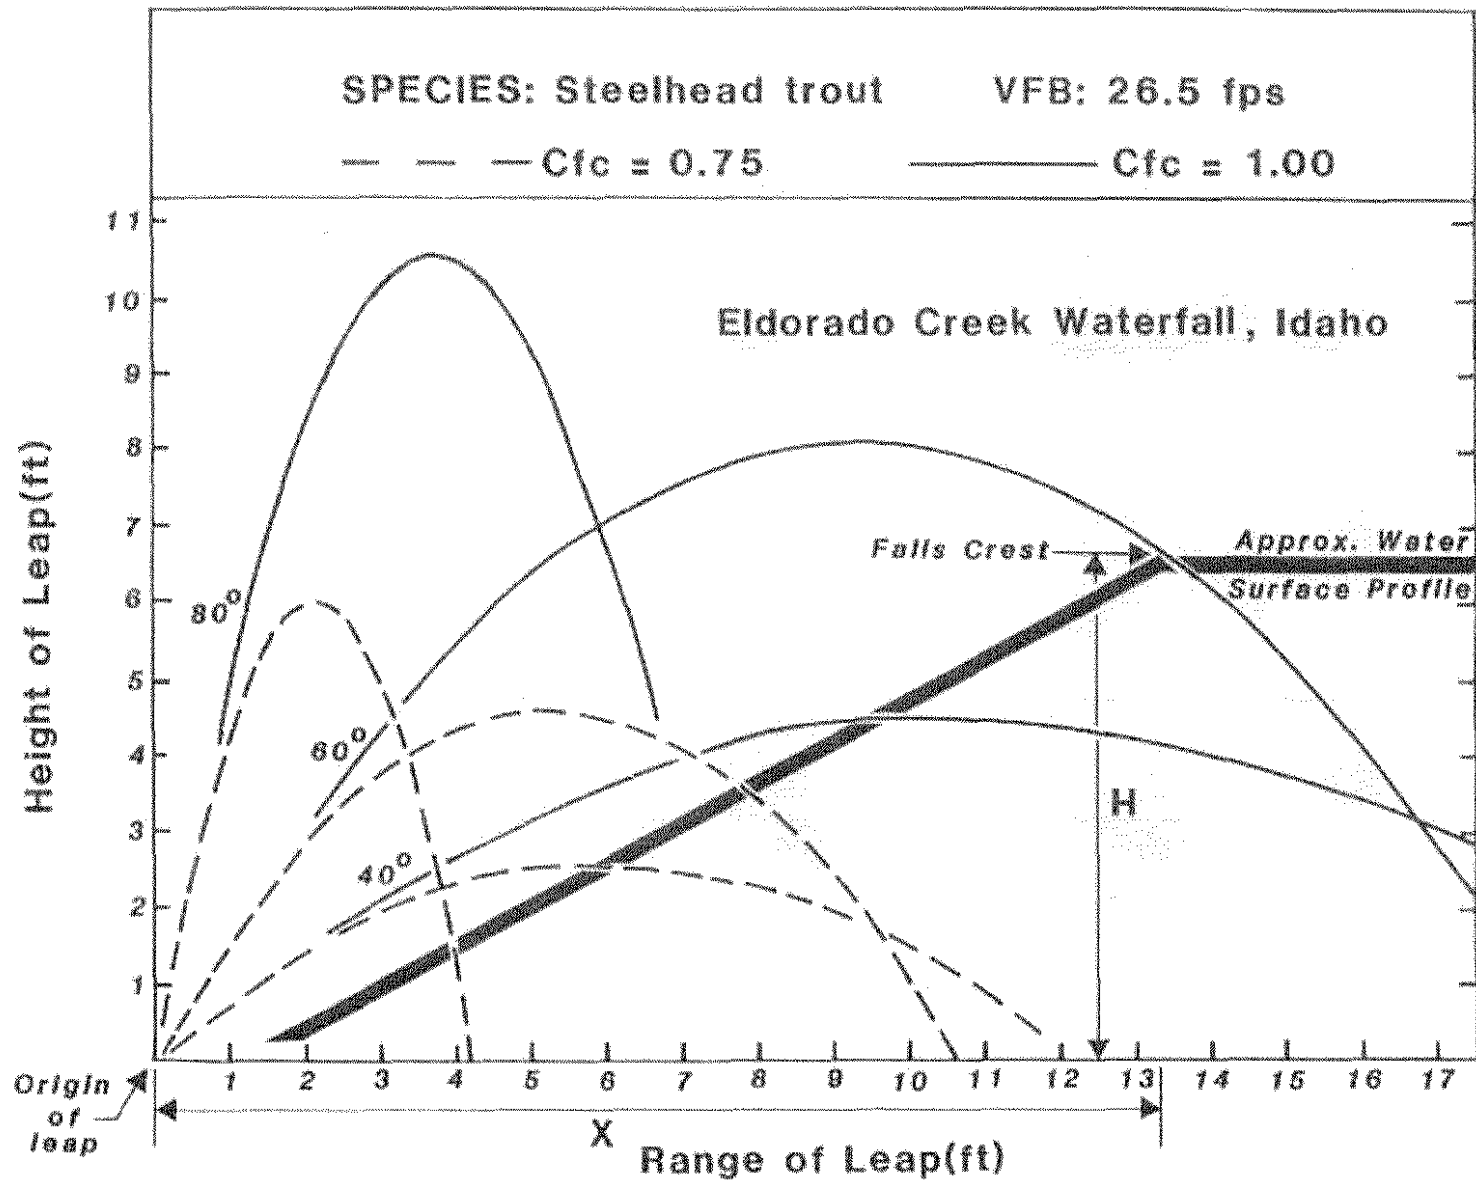
This analysis shows that even if the height the fish can leap (HL) is greater than the change in water surface elevation (H), and X is greater than XL, then a leaping fish will not reach the crest at the top of its leap. It will either fall short of the crest on its way down or reach the crest as it continues upstream on its descending parabolic path. These conditions are shown in Figure 23 for a steelhead trout. If the water surface profile of a barrier is superimposed on the fish leaping curves (Figure 23), the possibilities for a successful leap at a given leaping angle can be analyzed. The wide solid line shown is a falls barrier on Eldorado Creek in Idaho (Figure 24). The distances H and X were measured at the site. It can be seen from Figure 23 that a leaping angle of 60 degrees would allow passage. 80 and 40 degrees fall short of the crest by about 6 ft.

Figure 23. Eldorado Creek waterfall superimposed on steelhead leaping curves.

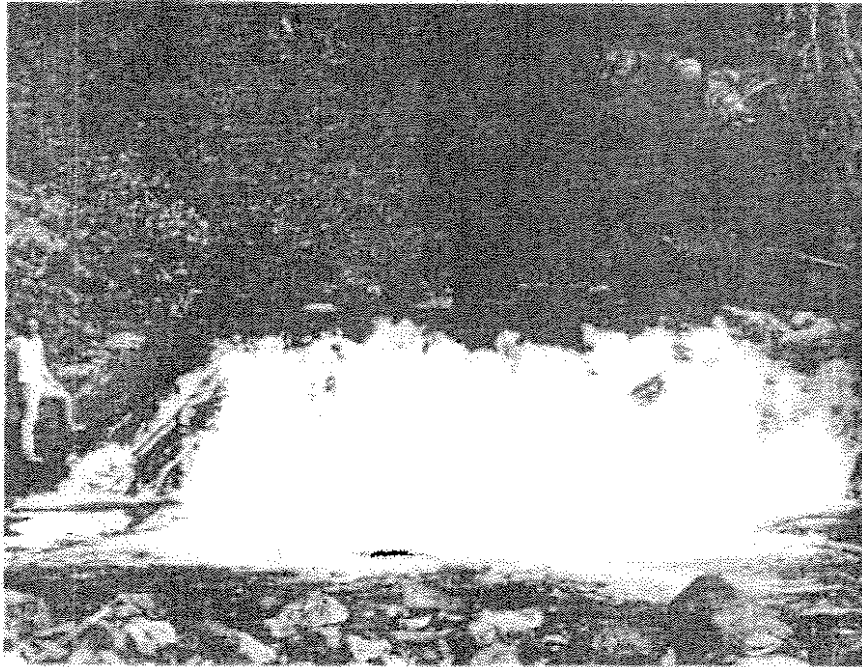
Figure 24. Looking upstream at Eldorado Creek Waterfall, Idaho.

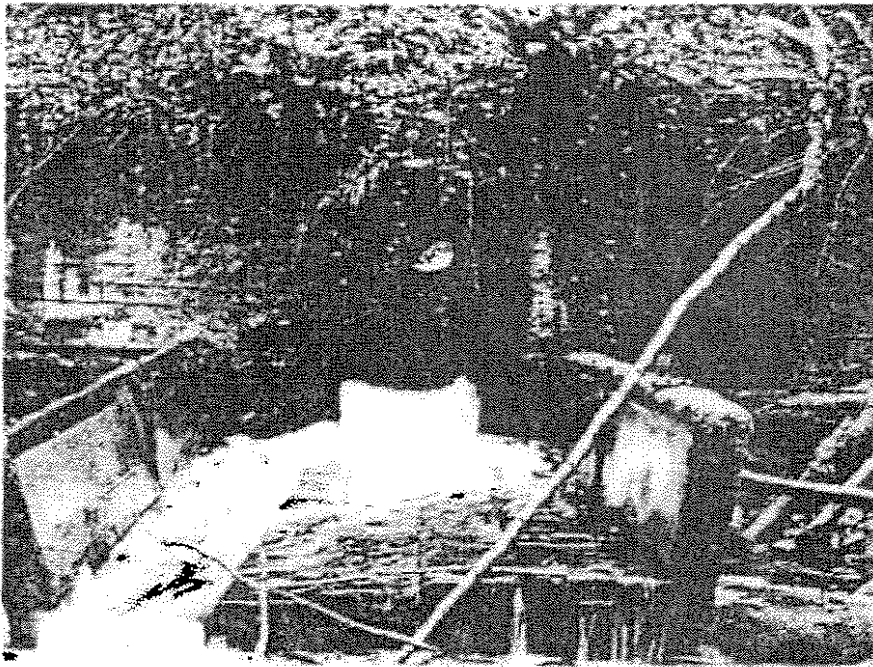
Figure 26.   Looking upstream at Red Cabin Creek culvert outlet.

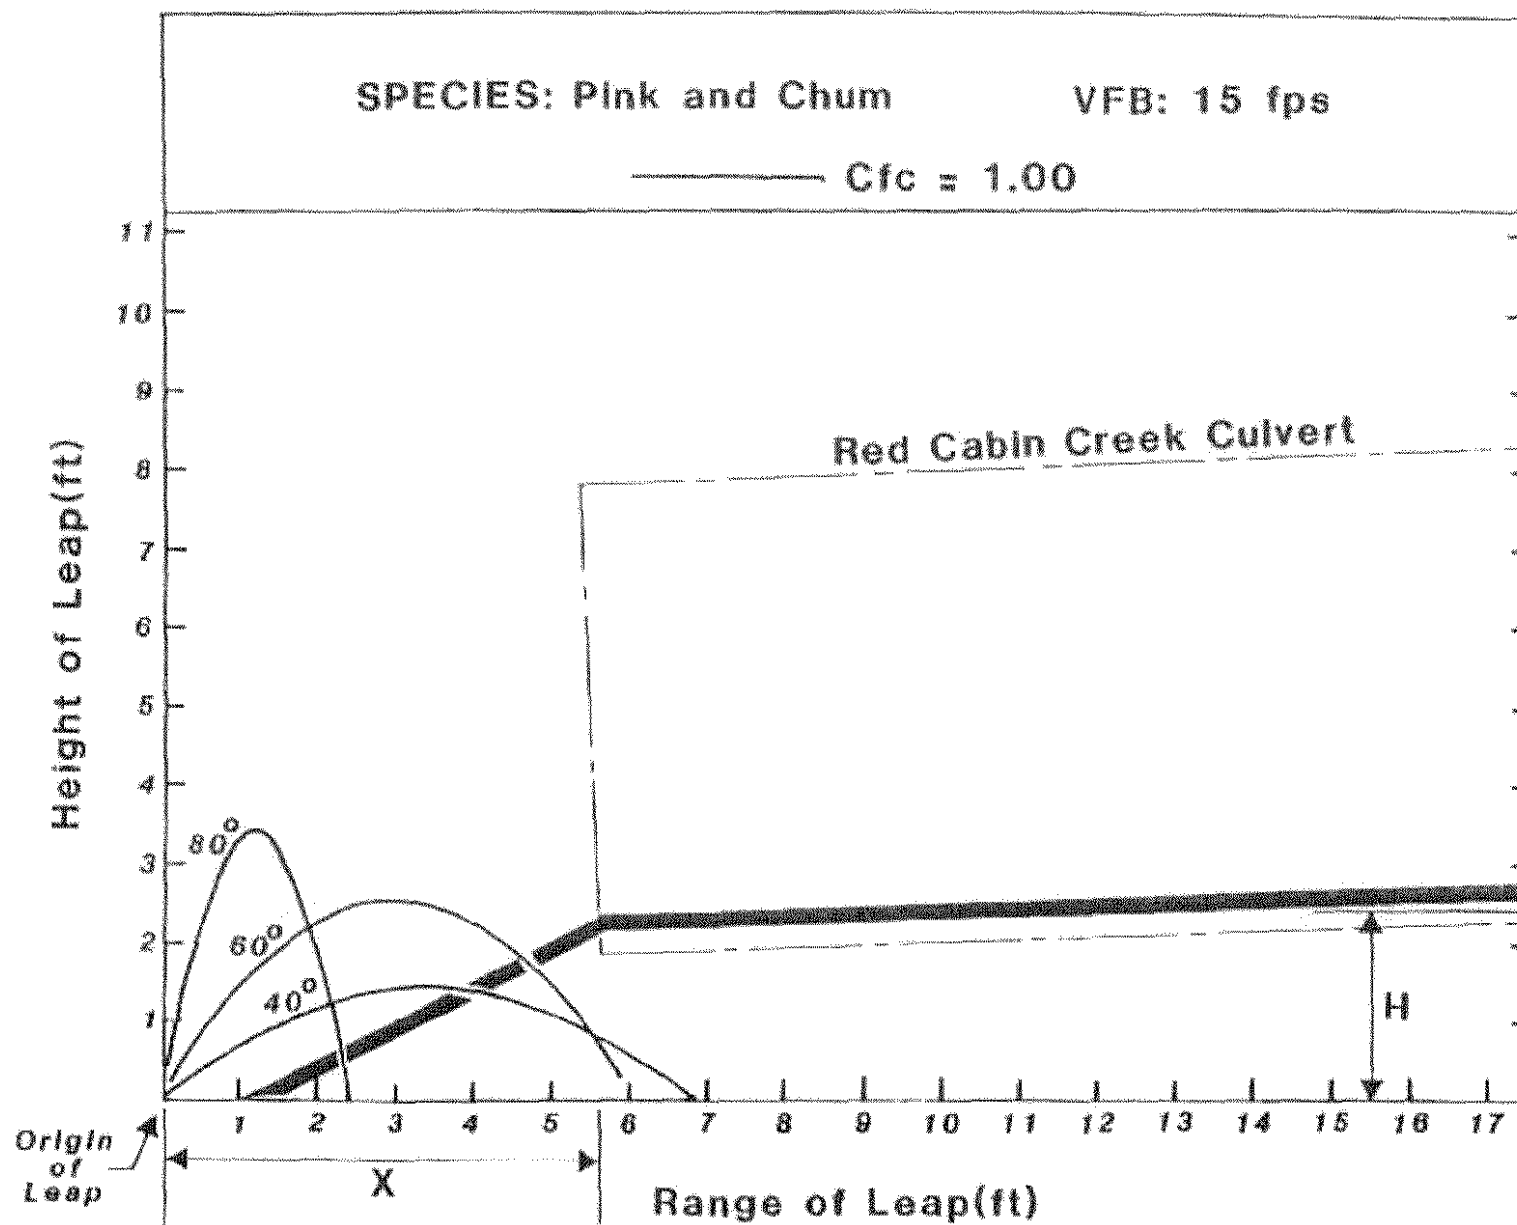
Superimposing H and X on Figures 8 and 9 shows coho and chinook will land right at the crest, and pink salmon about 1 ft short of the crest, at a leaping angle of 60 degrees (dotted lines Figures 27 and 28). This angle corresponds well with the calculated leaping angle of 51°. Because of the high velocities at the culvert outlet, the fish will not be able to land successfully and swim through. Therefore, the outfall drop is considered a horizontal distance (or range) barrier with adverse landing conditions.

Figure 2B. Red Cabin Creek culvert outlet superimposed on pink salmon leaping curves.

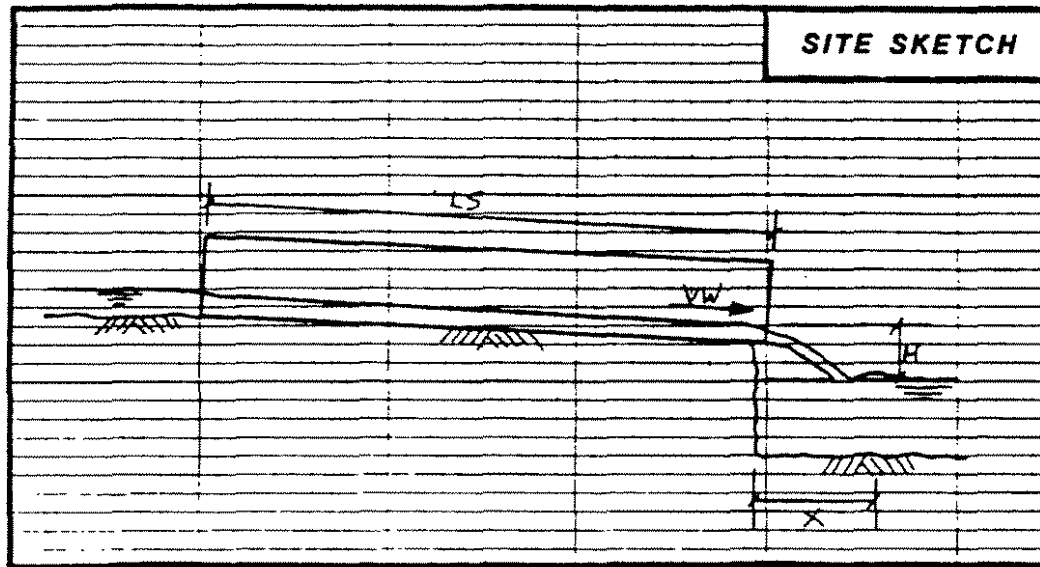
SITE: Red Cabin Creek Culvert   **DATE: 12/8/84**

CLASS: Compound (chute/fall)

TYPE: II C 1

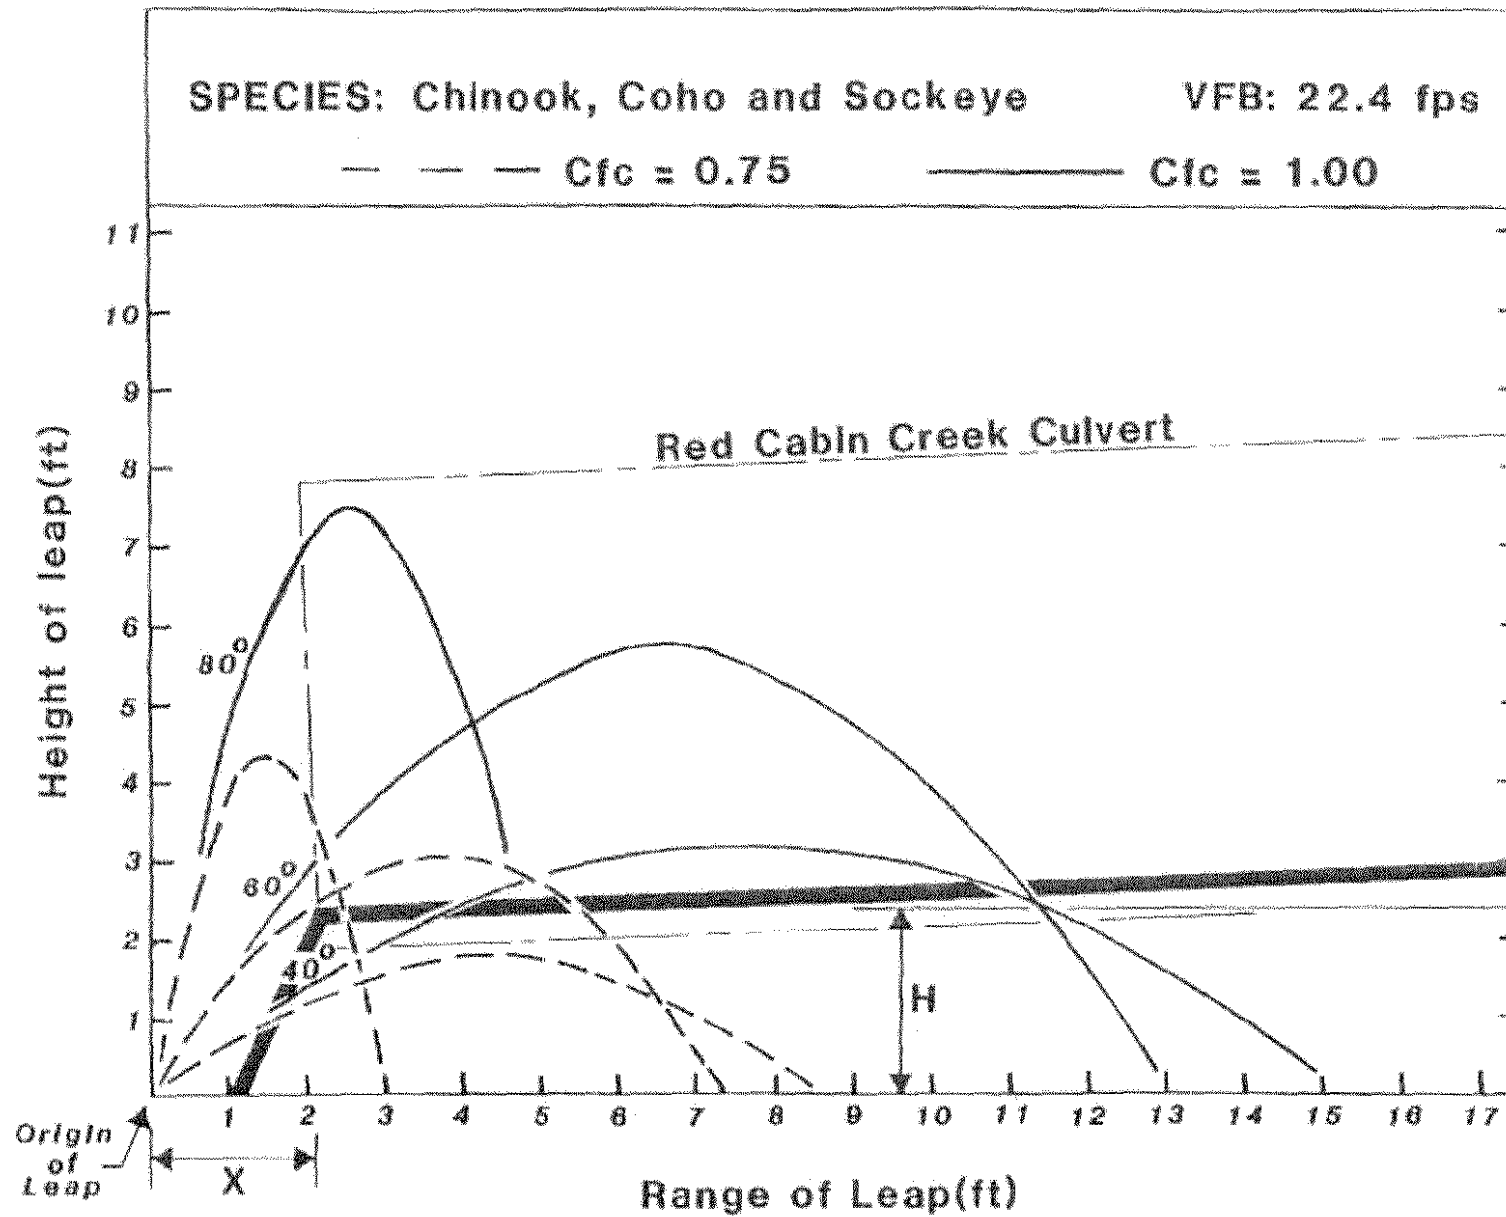
Superimposing the outfall geometry again on Figures 8 and 9 shows that coho, chinook and pink salmon can successfully enter the culvert at a leaping angle of about 60°, shown as dotted lines in Figures 30 and 31.

Figure 30. Red Cabin Creek "revised" culvert outlet superimposed on chinook and coho salmon leaping curves.

Problems	Solutions
Wooden scour apron prevents fish from entering culvert.	Remove apron.
Horizontal leaping distance is excessive, caused by high velocities at crest of 12.9 fps.	Decreasing velocity to 3 fps at the crest would reduce the horizontal leaping distance and allow successful passage.
Velocity in the culvert is excessive for a culvert lenath of 150 ft.	Add baffles or some type of roughness elements to decrease the velocity. Check culvert capacity to pass flood flows.
Debris jam in middle of culvert prevents fish passage.	Remove debris

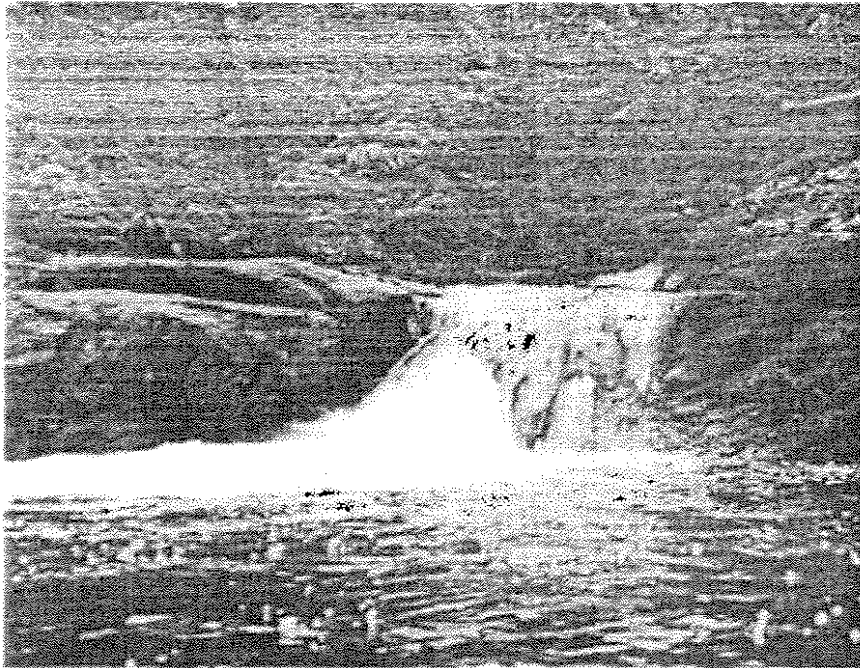
Figure 32. Looking upstream at Chuckanut Creek waterfall.

Waterfall Description: In the upstream section the harrier begins with a short, narrow rock chute (triangular Cross section) which terminates in a 2 to 3 it drop. At the drop there is 3 rock/sandstone overhang which say obstruct passage to the upper chute of the barrier, Figure 33. The main openinq for passage appears to present a very shallow depths near the crest. This waterfall does not appear to he an elevation or velocity barrier, but because of the rock overhang it may present orientation problems. Steelhead have been observed by Dept. of Fisheries personnel to successfully pass the barrier, hut have also been observed falling back after landing near the crest.

also allow the fish to get further upstream before they attempt their leap, and decrease the horizontal leaping distance (X). Even at high flow, the majority of the flow would he concentrated in the deeper low flow channel.

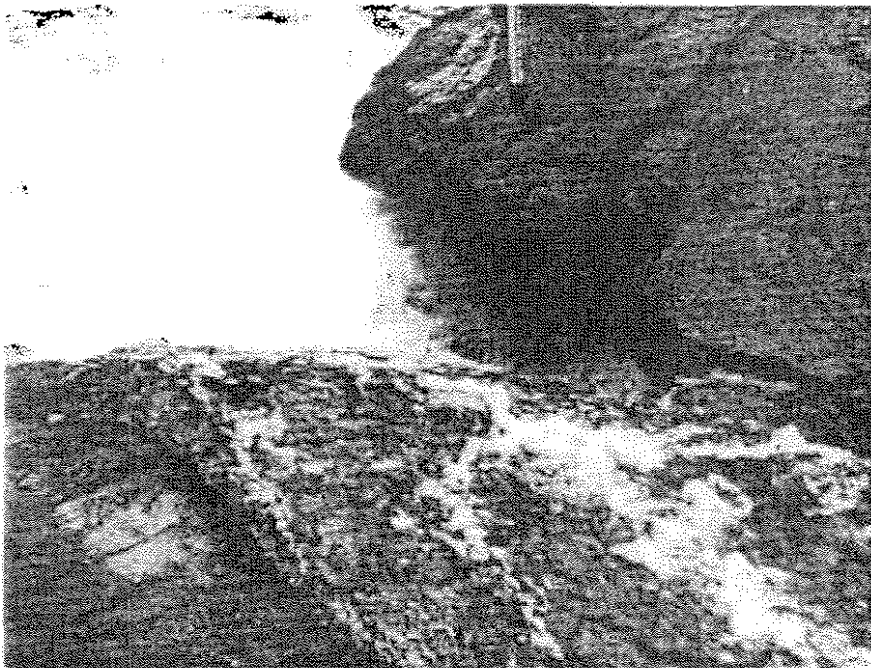
Figure 33. Plan view of obstructing rock near Chuckanut Creek waterfall crest.

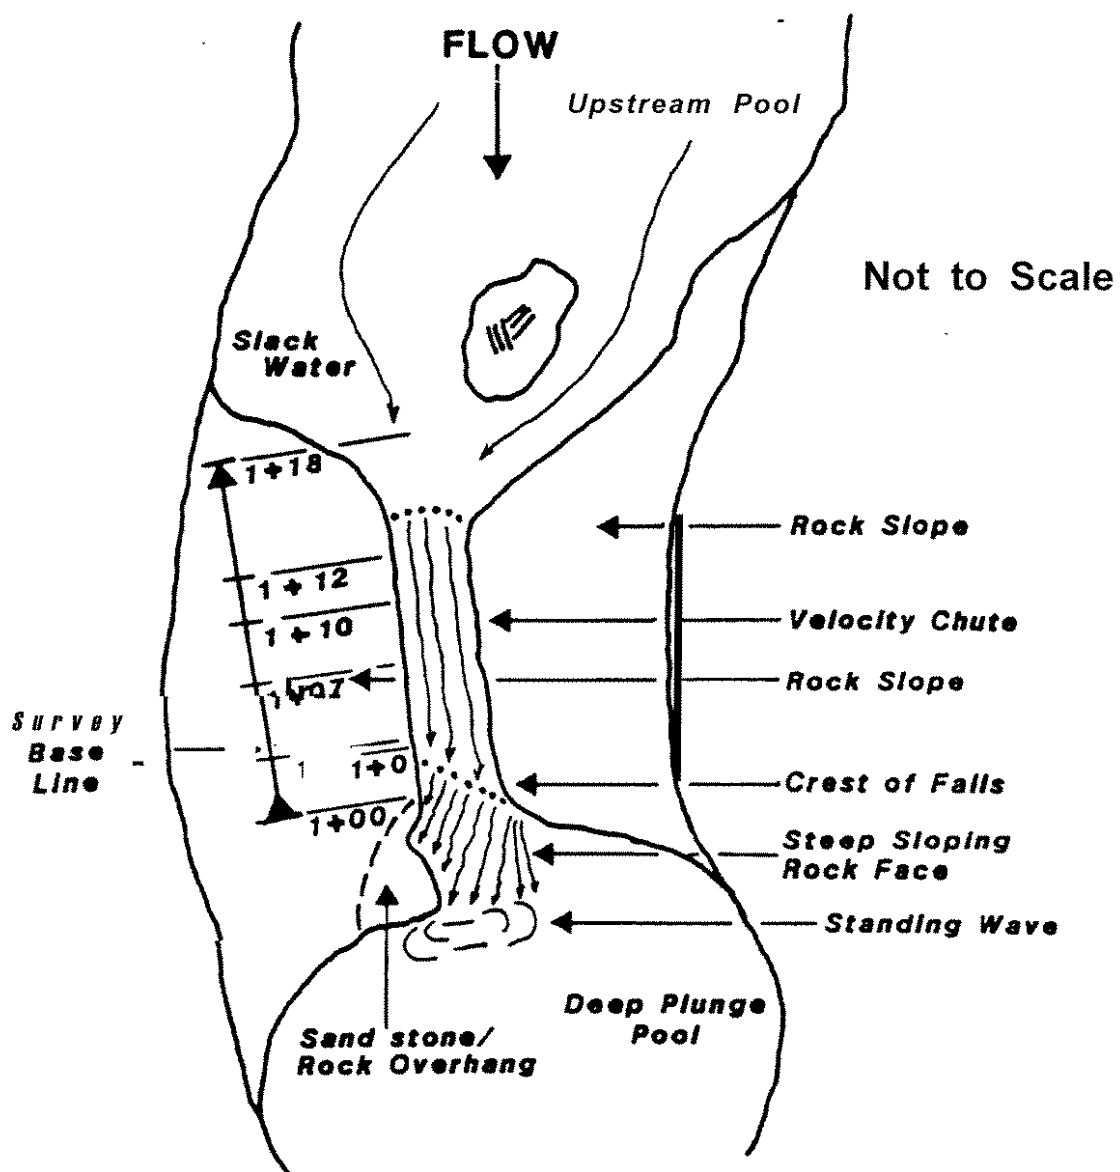
Figure 34. Plan view sketch of Chuckanut Creek waterfall.

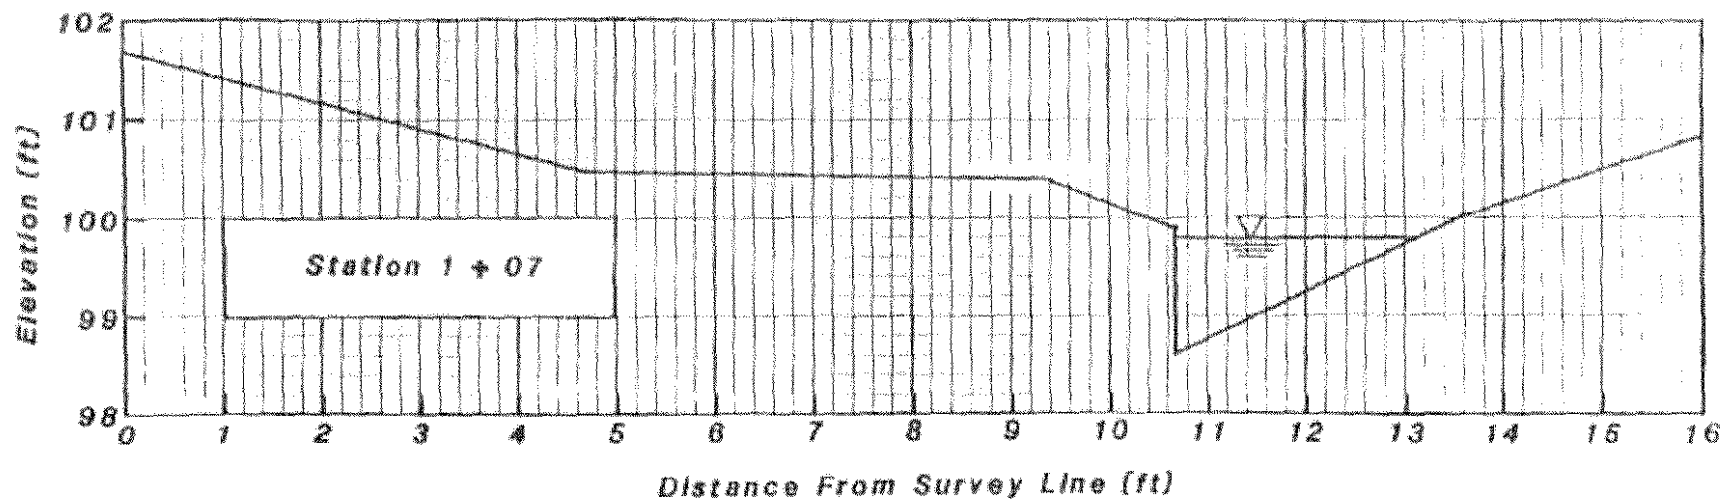
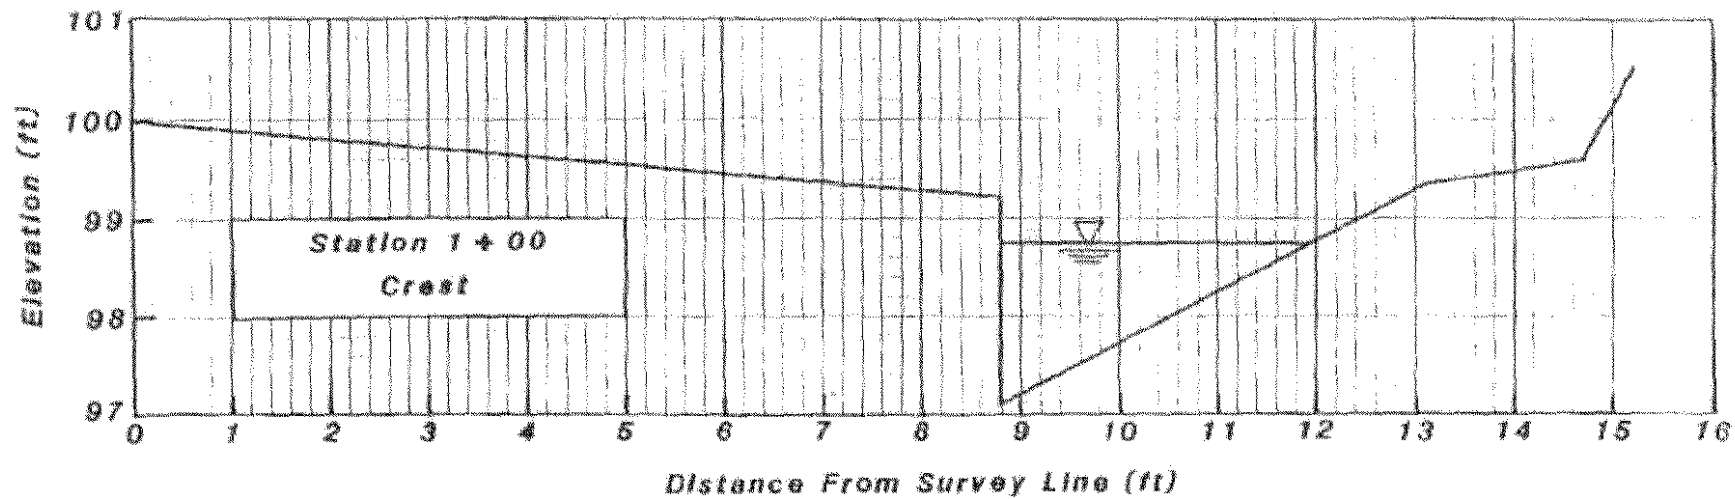
Figure 35. Cross sectional areas of stations 1+00 and 1+07 at Chuckanut Creek waterfall looking upstream.

Therefore at station 1+07, the average velocity the fish must face assuming a discharge of 8.0 cfs is 5.3 fps. A similar analysis was applied to station 1+00 (Figure 35, the crest), and an average velocity of 3.1 fps was calculated. The velocity decreases near the crest because of the increased flow area from station 1+07 to 1+00.

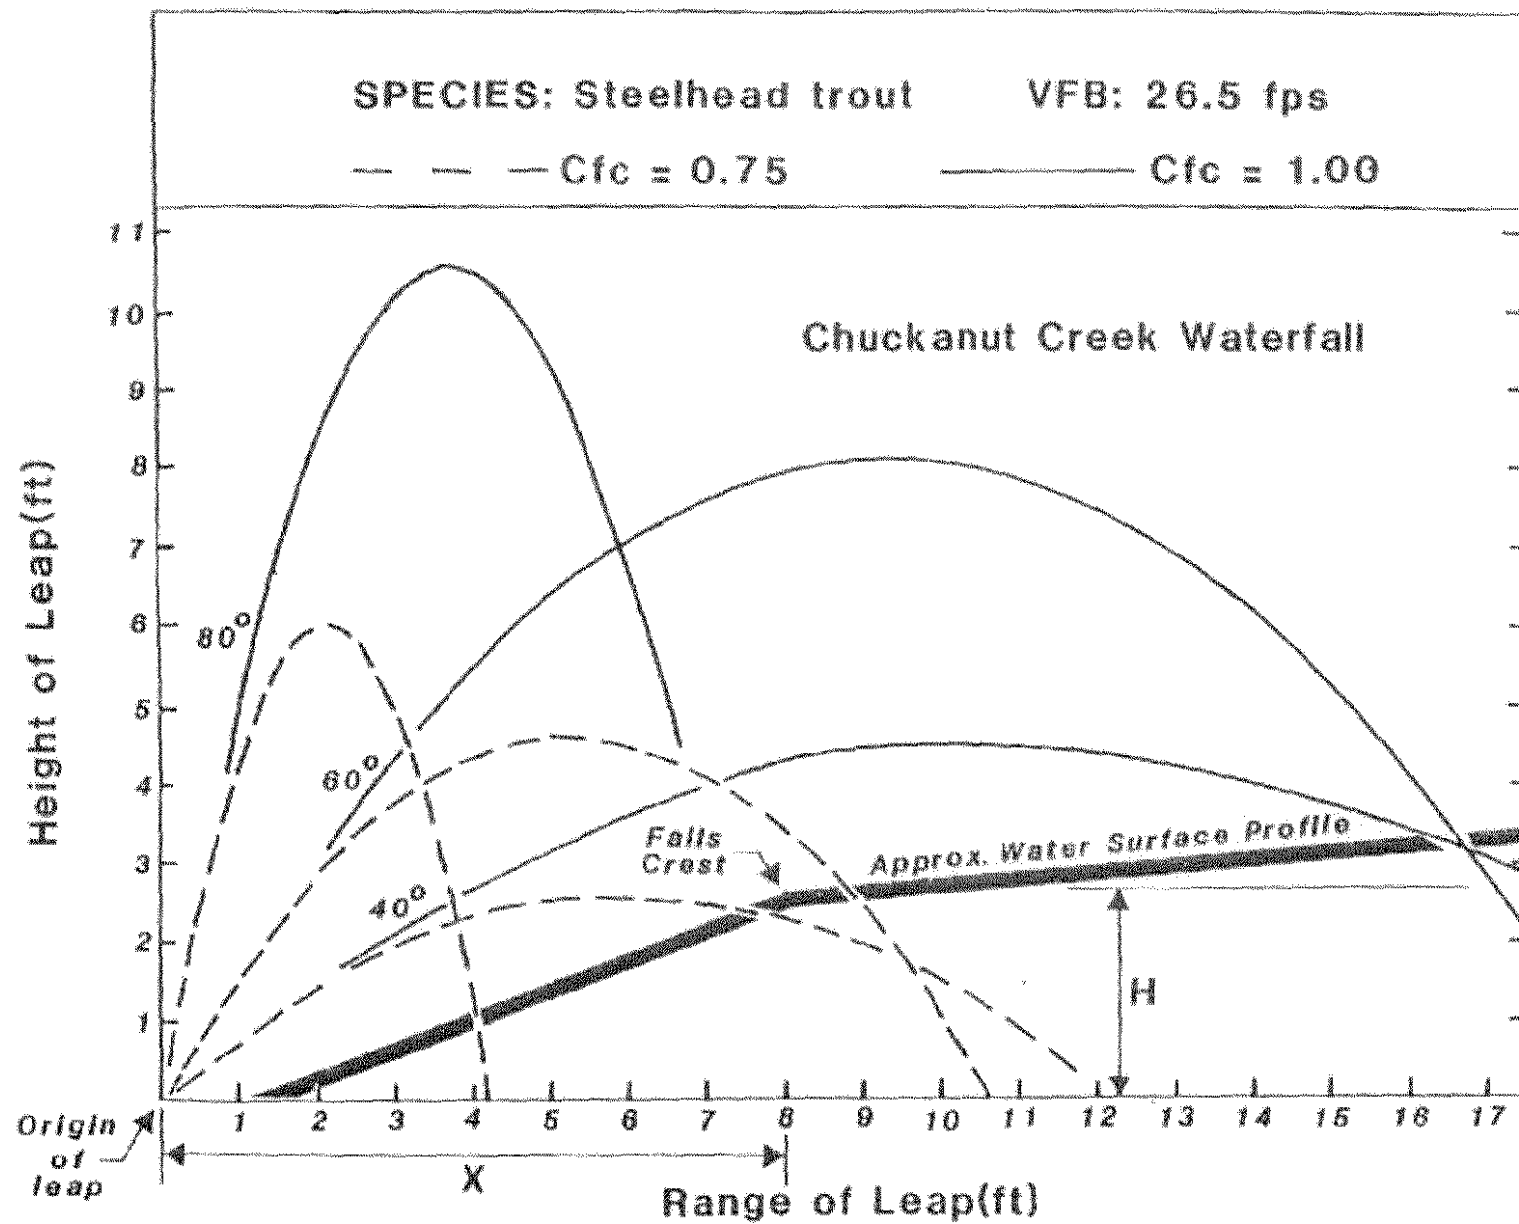
1. Steelhead and coho can successfully pass at leaping angles of 60 and 40 degrees (Figures 36 and 37).

Figure 36. Chuckanut Creek fall superimposed on steelhead leaping curves.

A very good low flow channel is present above the falls, upstream from the falls crest. Referring to Figure 33, if the overhanging rock was removed, the fish would have a "straight-shot" into the upper chute. Also, they would be attracted to leap at the area of highest flow momentum because of the deep channel on the left side (looking upstream). This would

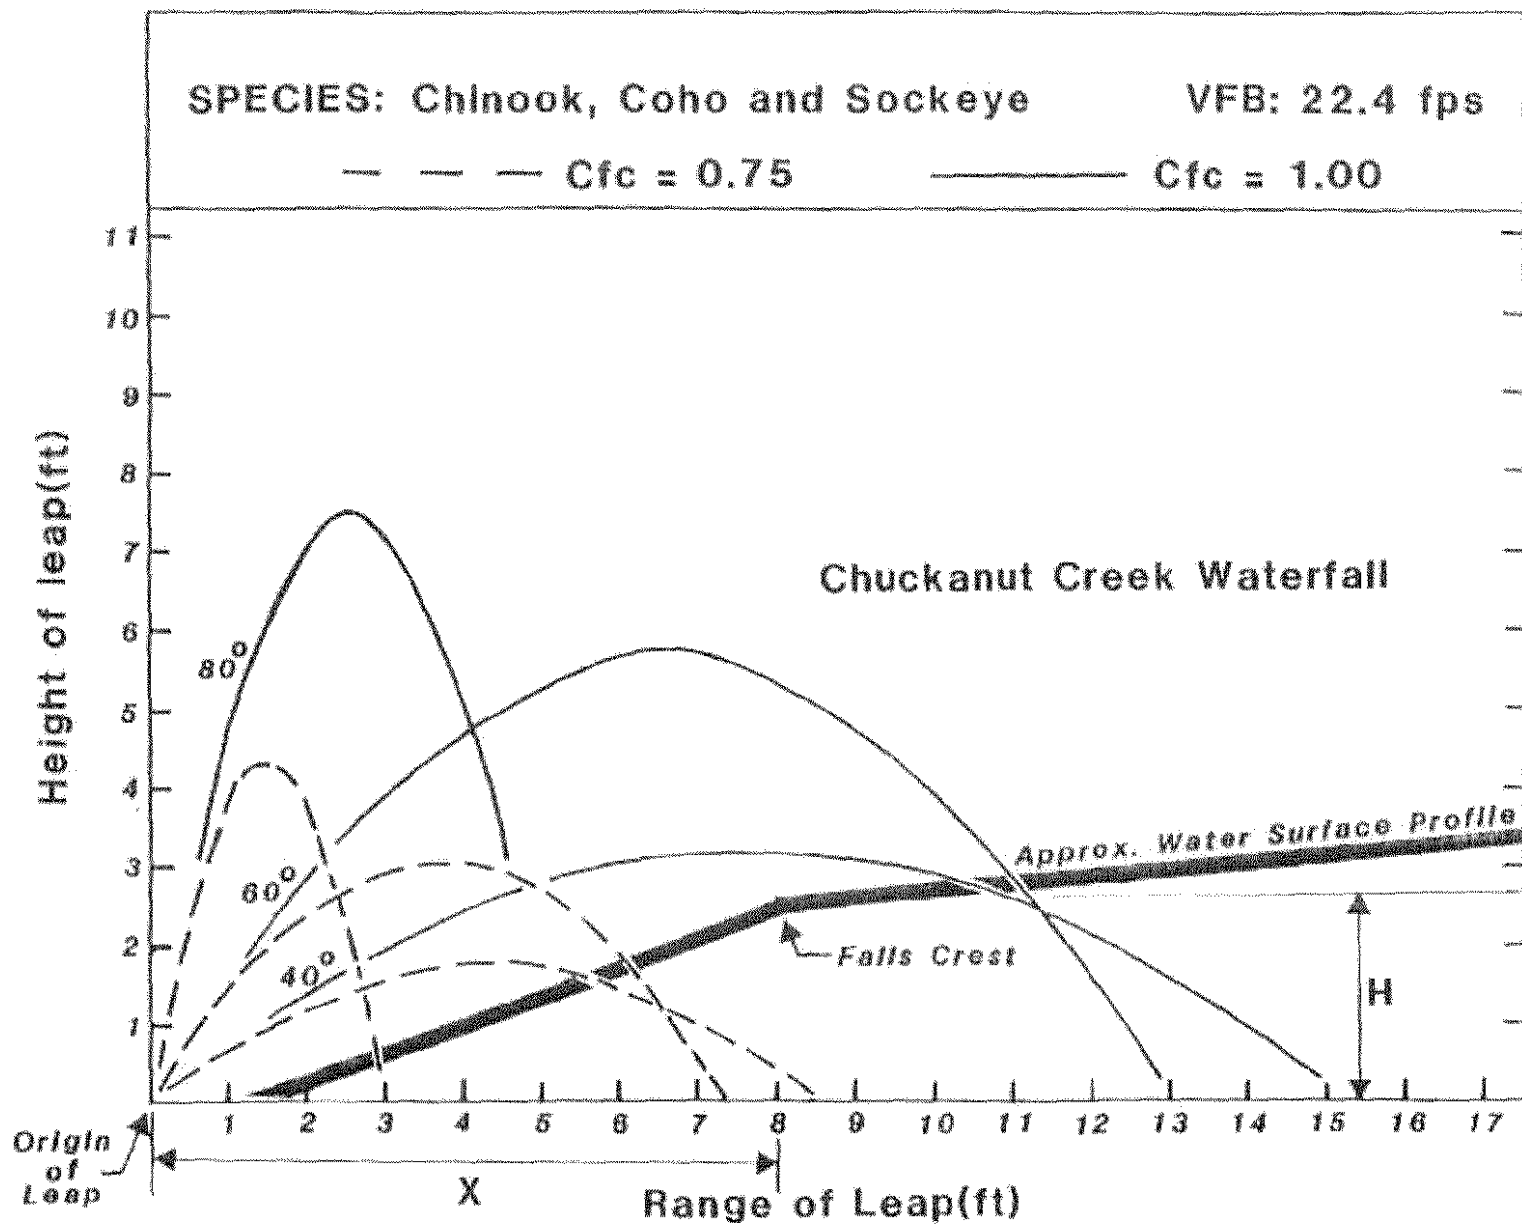
Figure 37. Chuckanut Creek fall superimposed on coho salmon leaping curves.

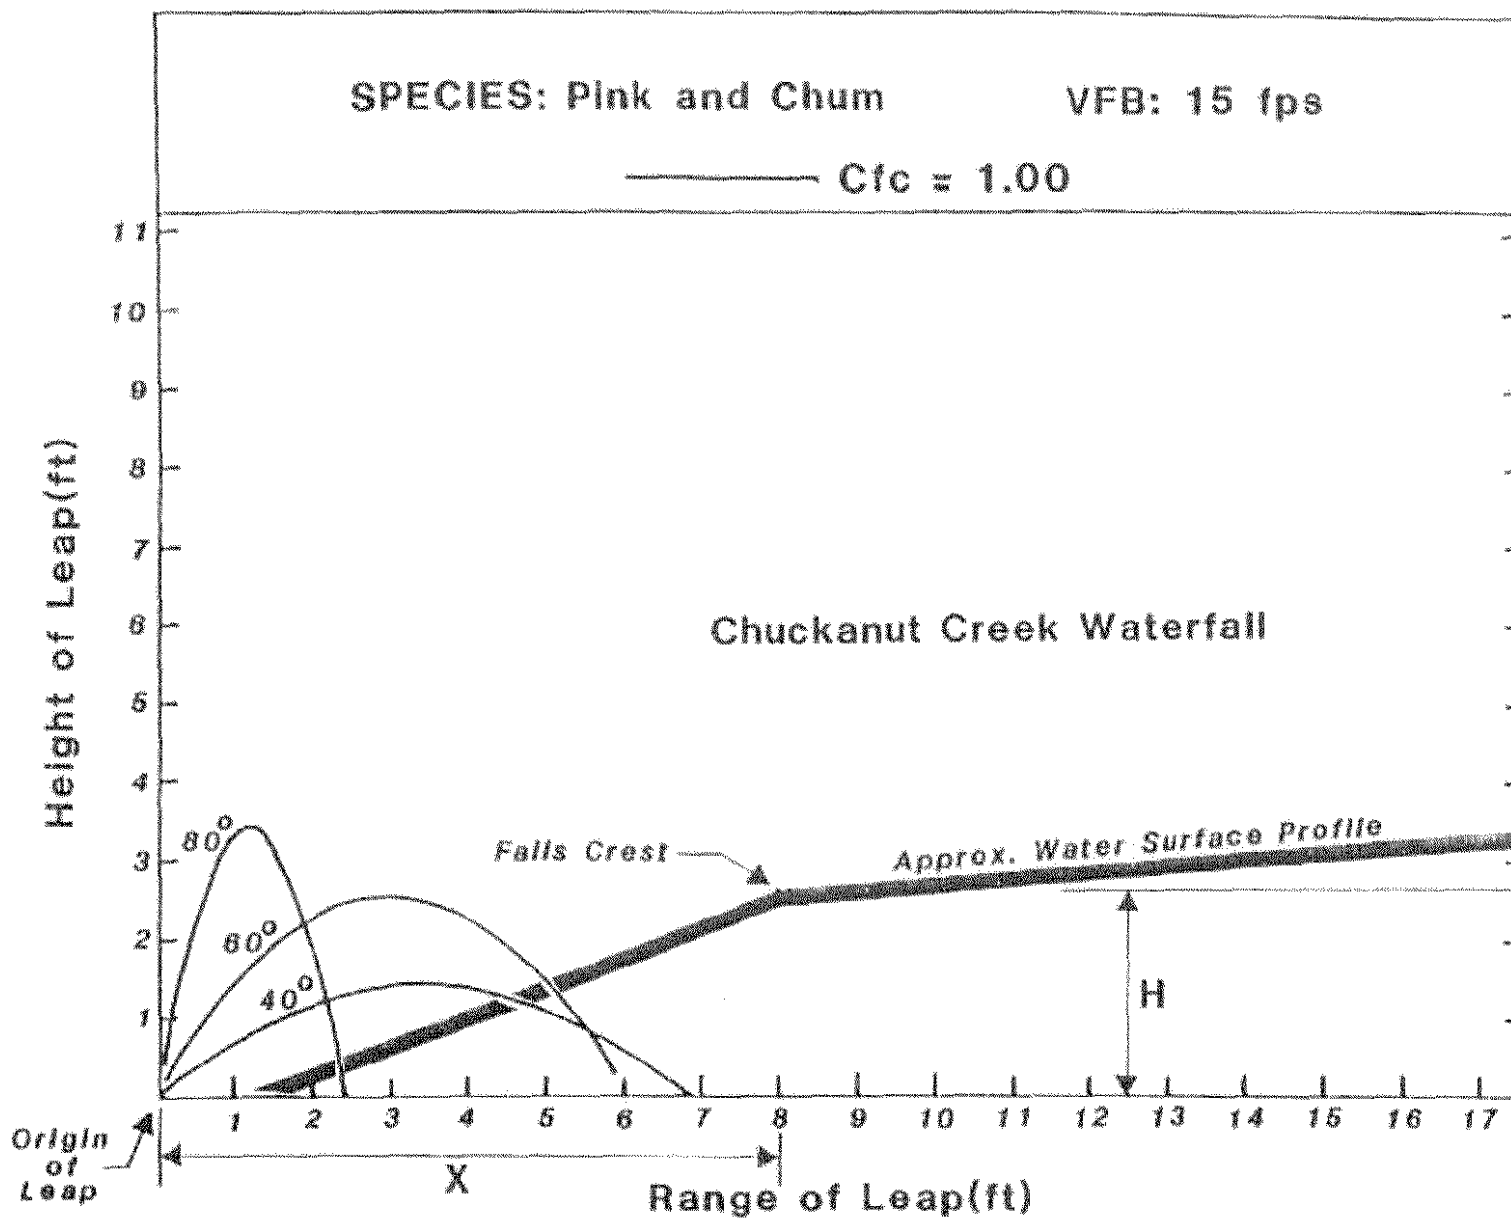
2. Chum salmon will fall short of the crest by about 4 ft at leaping angles of 60 and 40 degrees (Figure 38).

Figure 38. Chuckanut Creek fall superimposed on chum salmon leaping curves.

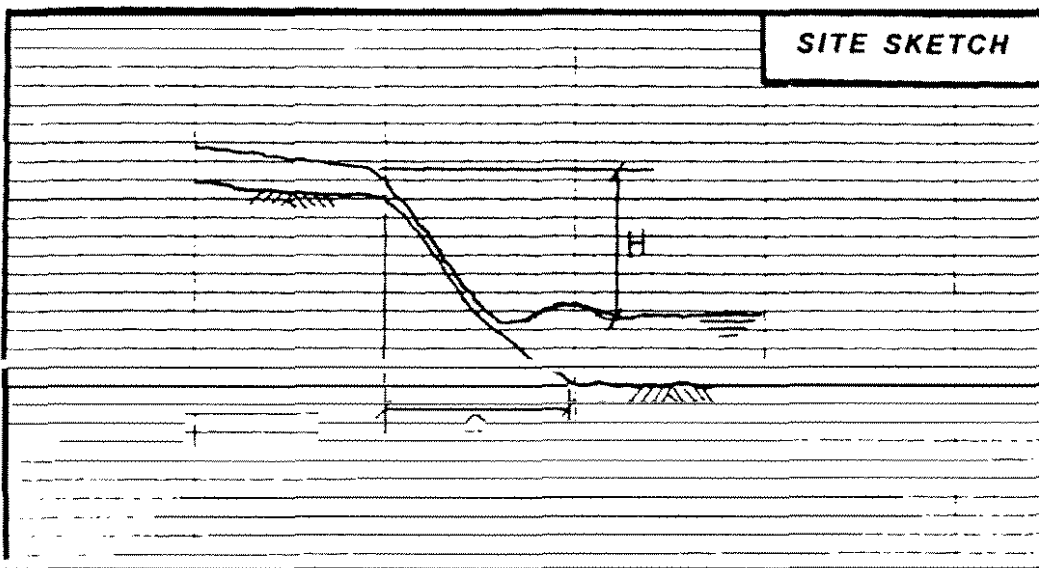
SITE: **Chuckanut Creek Waterfall** DATE: **12/8/84**

CLASS: **Single Fall**

TYPE: **ⅡA 1**
