*A Watershed Management Procedure*

U.S. Department of Agriculture  
Forest Service/Northern Region

## STREAM REACH INVENTORY AND CHANNEL STABILITY EVALUATION

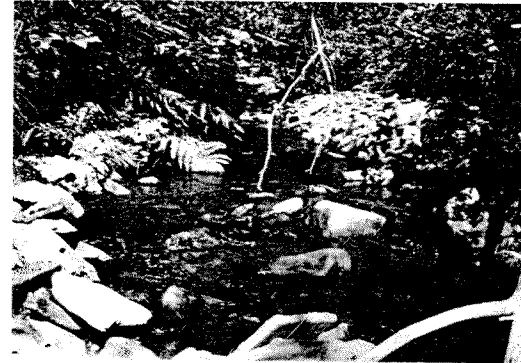
*Channel evaluations are best made during periods of low flow.*

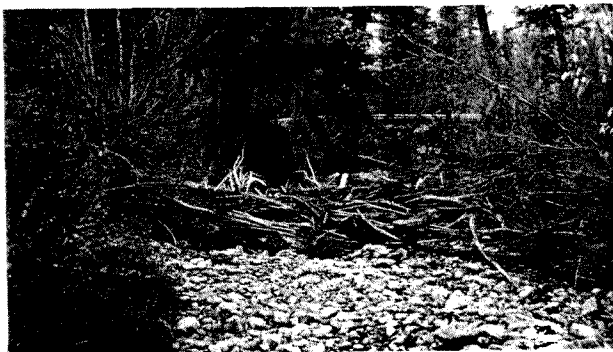
*A series of debris jams of small size materials like the one shown in the center of this photo cause this item to be rated "Poor".*

C. Debris Jam Potential Floatable objects are deposited on stream banks by man and as a natural process of forest ecology. By far, the bulk of this debris is natural in origin. Tree trunks, limbs, twigs, and leaves reaching the channel form the bulk of the obstructions, flow defectors, and sediment traps to be rated below. This inventory item assess the potential for increasing these impediments to the natural direction and force of flow where they now lay. It also includes the possibility of creating new debris jams under certain flow conditions.

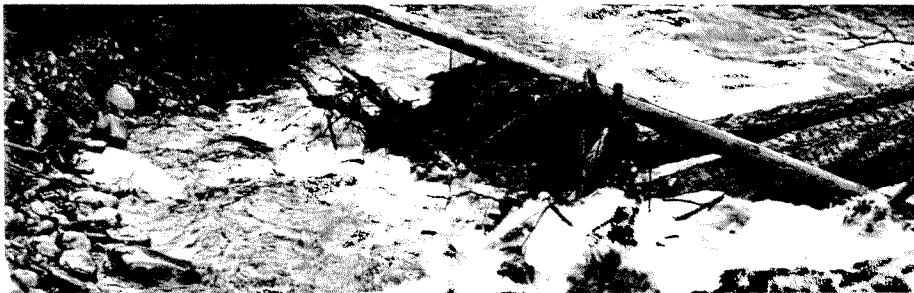
*Overturnd shoreline trees become obstructions and flow deflectors as shown here. If frequent in the reach, rate this item "Poor".*

- C. Obstructions and Flow Deflectors: Objects within the stream channel, like large rocks, embedded logs, bridge pilings, etc., change the direction of flow and sometimes the velocity as well. Obstructions may produce adverse stability effects when they increase the velocity and deflect the flow into unstable and unprotected banks and across unstable bottom materials. They also may produce favorable impacts when velocity is decreased by turbulence and pools are formed.

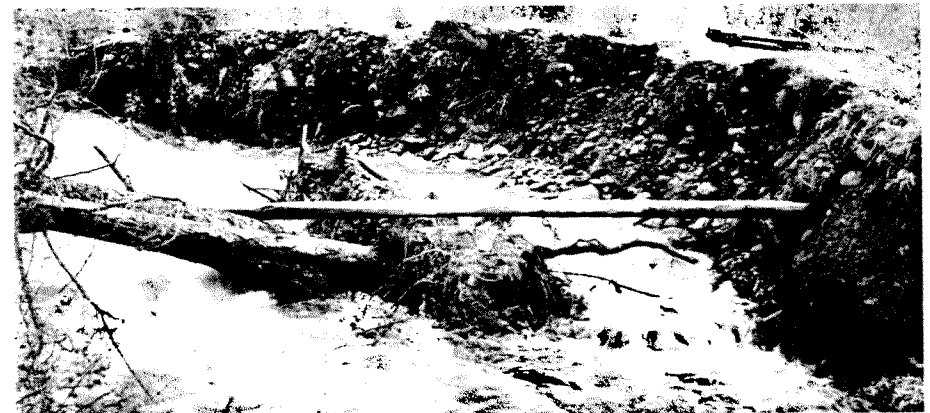
*Same location as shown on page 14, but looking upstream. Obstruction like this could become the nucleus of a debris jam.*

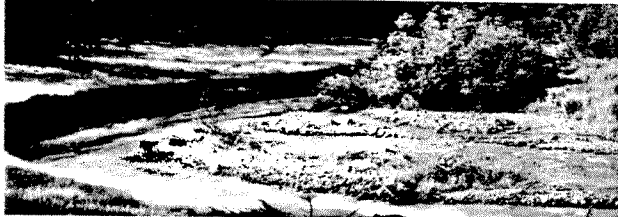
*Poor bank conditions at this bend are evident.*

1. Excellent: Very little or no cutting is evident. Raw, eroding banks are infrequent, short and predominately less than 6" high.
2. Good: Some intermittent cutting along channel out-curves and at prominent constrictions. Eroded areas are equivalent in length to one channel width or less and the vertical cuts are predominately less than 12".
3. Fair: Significant bank cutting occurs frequently in the reach. Raw vertical banks 12" to 24" high are prevalent as are root mat overhangs and sloughing.
4. Poor: Nearly continuous bank cutting. Some reaches have vertical cut faces over 2 feet high. Undercutting, sod-root overhangs and vertical side failures may also be frequent in the rated reach.

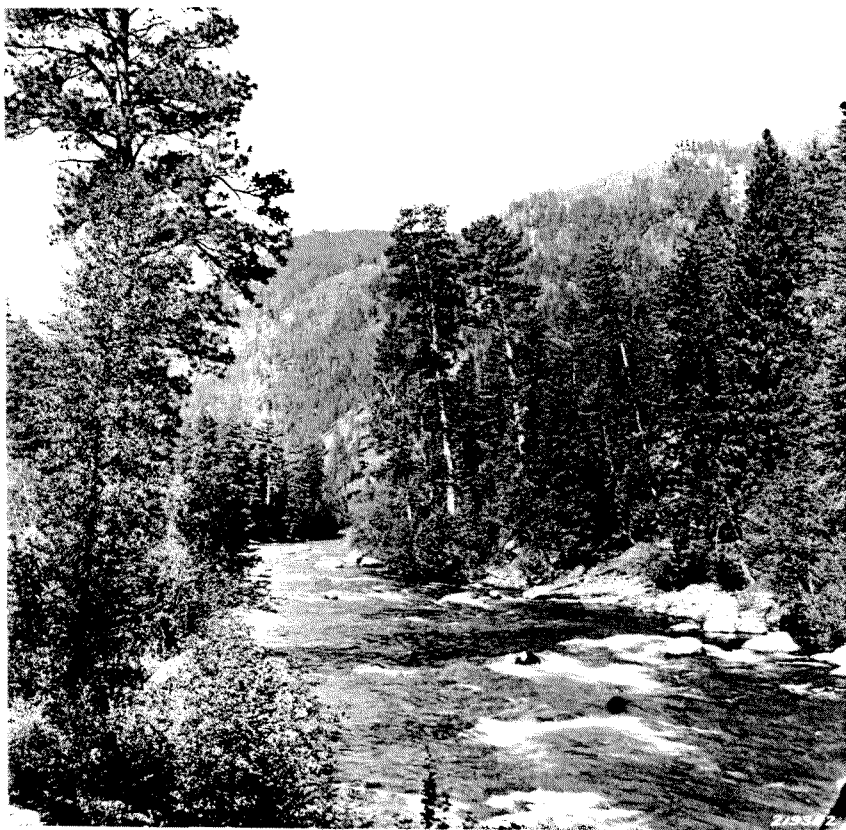
*This large stream channel reach  
would be rated "excellent" overall.*
