Flood Surge on the Rubicon River, California— Hydrology, Hydraulics and Boulder Transport

GEOLOGICAL SURVEY PROFESSIONAL PAPER 422-M

By KEVIN M. SCOTT *and* GEORGE C. GRAVLEE, JR.

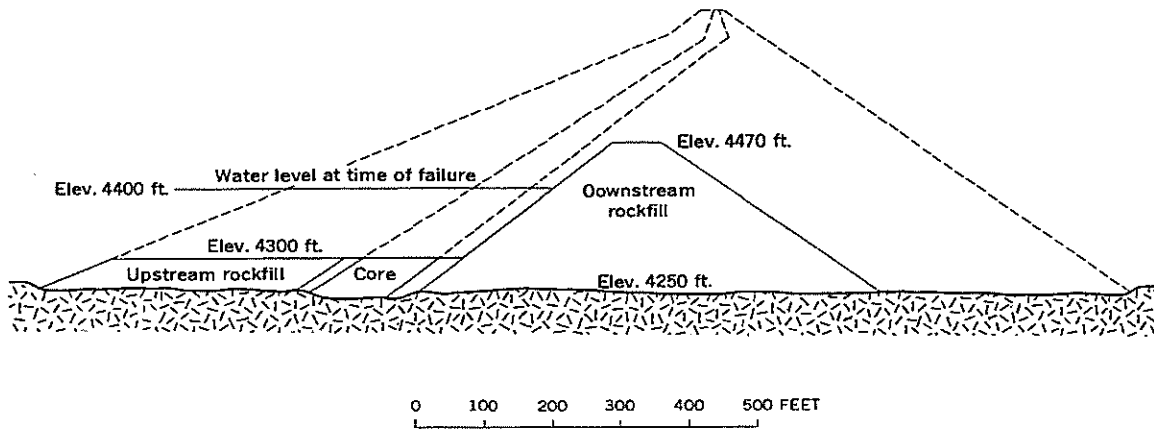
FIGURE 5.—Cross section of the completed Hell Hole Dam (dashed lines) and the stage of construction at the time of failure (solid lines).

A cross section of the stage of completion at the time of failure (fig. 5) indicates that the downstream rockfill had been completed to an elevation of 4,470 feet, 220 feet above the streambed. The impervious earth core, to act as a seal on the upstream side of the main supporting rockfill, had been placed to an elevation of 4,300 feet, approximately 50 feet above the streambed, at the time of the storm. Impoundment of storm runoff had reached the level of the core crest by 1:30 p.m., December 21, 1964, and only 34 hours later the water level had moved an additional 72 feet up the face of the pervious rockfill. Water began flowing through the rockfill shortly after the core was overtopped, and flow increased as the level rose.

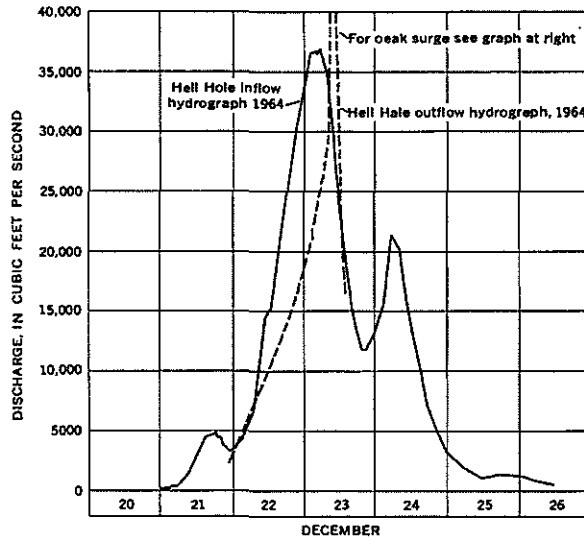
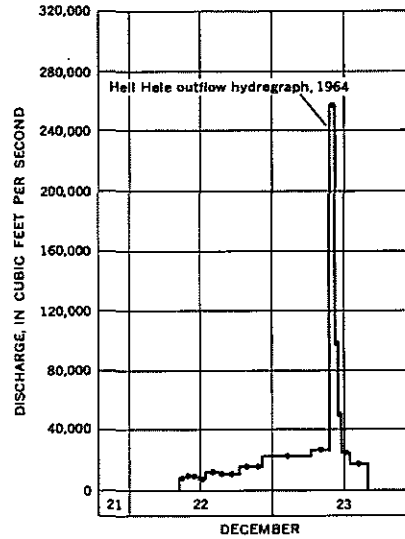
FIGURE 8.—Flow and storage data associated with the failure of Hell Hole Dam in December 1964.

The only data available for computing inflow and outflow at Hell Hole Dam were a record of storage of impounded water behind the dam during the flood period (fig. 8) and a chronology of the dam failure, both supplied by McCreary-Koretsky Engineers. It was

A. Inflow and outflow hydrographs at Hell Hole Reservoir

B. Hydrograph of peak surge outflow at Hell Hole Reservoir

C. Record of storage in Hell Hole Reservoir

D. Hydrographs at Middle Fork American River near Auburn

The gage on the Middle Fork American River near Auburn operated throughout the flood and strikingly shows the surge caused by the failure (fig. 8). The computed volume of water in the surge is 24,800 acre-feet at this station.

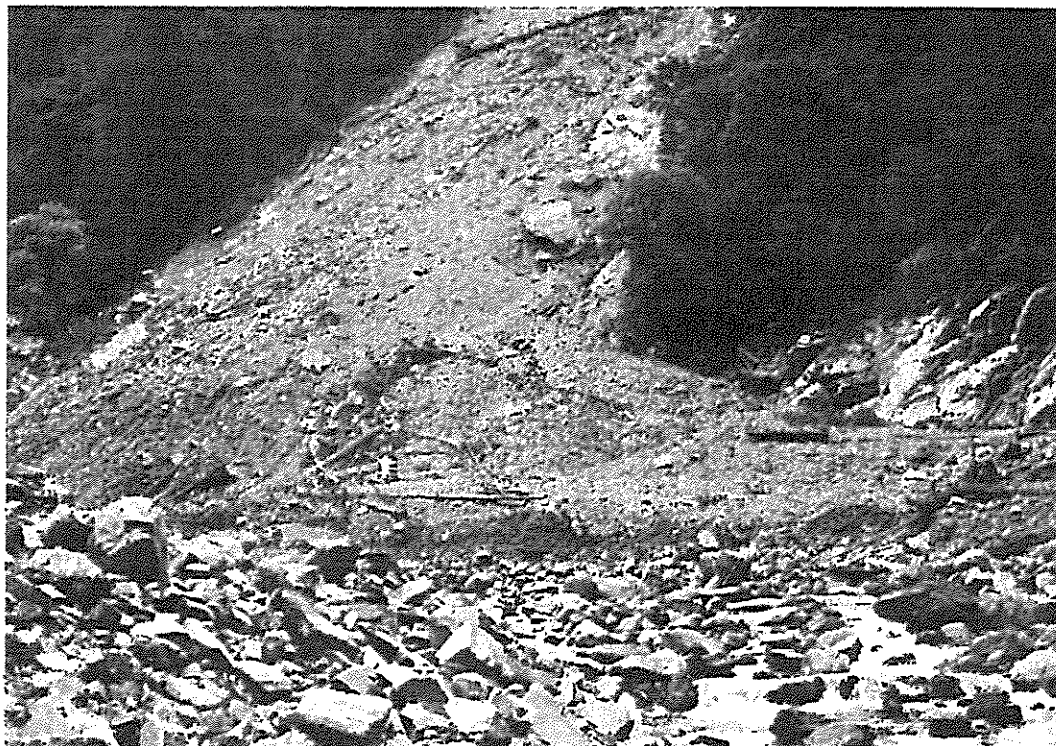
FIGURE 12.—Base of the largest slide in the Rubicon gorge, 0.5 mile downstream from the mouth of Little Grizzly Canyon, 18.7 miles downstream from Hell Hole damsite. Note scour due to surge at right, the downstream direction. Helicopter, right, indicates scale.

The slope failures are commonly triangular in plan view and the largest has a maximum toe width of 630 feet. Slide scars reach a maximum elevation of 500 feet

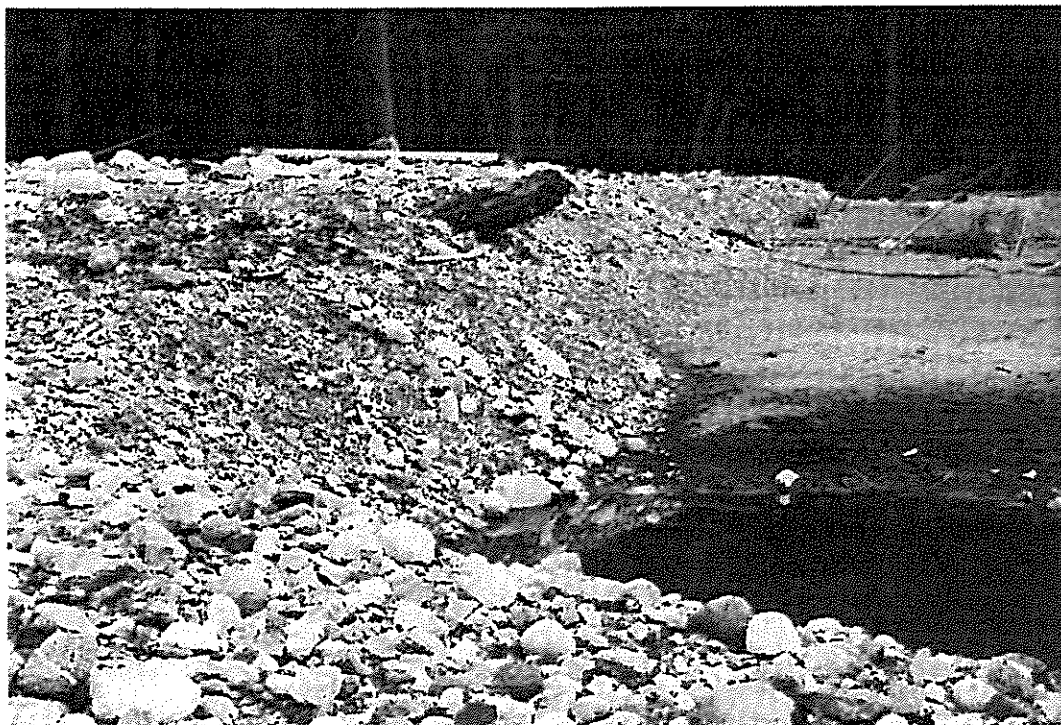
FIGURE 18.—View across flood channel of boulder front on Parsley Bar. Maximum height of the front is 7.2 feet. Note trees tilted in a downstream direction, to the right.

An arcuate boulder front 3-7 feet high extends 250 feet across the flood channel in the middle of Parsley Bar (figs. 18, 19). The front represents a point to which, at a late stage of the surge passage, boulders as much as 10.5 feet in intermediate diameter were transported, but beyond which little coarse material was moved. The boulder deposit transgressed across and only partly replaced a sand layer 2-8 feet thick that was deposited during an earlier interval of surge recession. Numerous small trees in growth position protrude through the sand layer which was molded into longitudinal and arcuate transverse dunes. Similar boulder fronts on a
